Minerals Inspection Report

Mine Name: Ekins #2	Permit Number: S/49/0088	Mine Status: Active
Operator Name: SK Materials LLC	Inspection Date: 11/05/2014	Permit Fees: Paid
Inspector(s): A. Abate	Inspection Time: 10 AM	Bond Amount: \$3,145
Attendee(s): Steve Clement	Weather: Cloudy	Bond Escalation: Nov 2017
Inspection Purpose: Routine inspection		Prior Inspection: 3/6/2014

Mine: S/49/0088

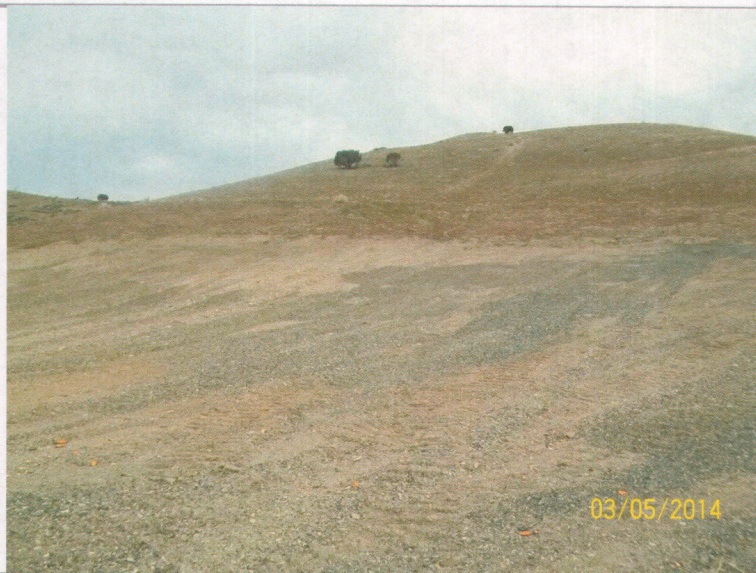
Slope of reclaimed original one-acre permit March 2014

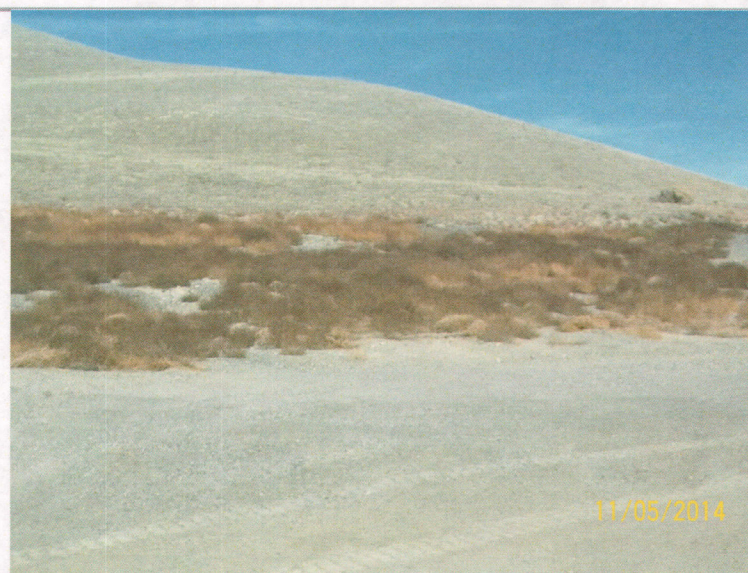
5.	<i>Roads (maintenance, surfacing, dust control, safety)</i>	<input type="checkbox"/>	<input type="checkbox"/>
6.	<i>Reclamation</i>	<input checked="" type="checkbox"/>	<input type="checkbox"/>
The operator has regraded and seeded the original one acre. The vegetation is coming in nicely although a little more diversity in species would be ideal.

View of the same reclaimed area November 2014 after one growing season.

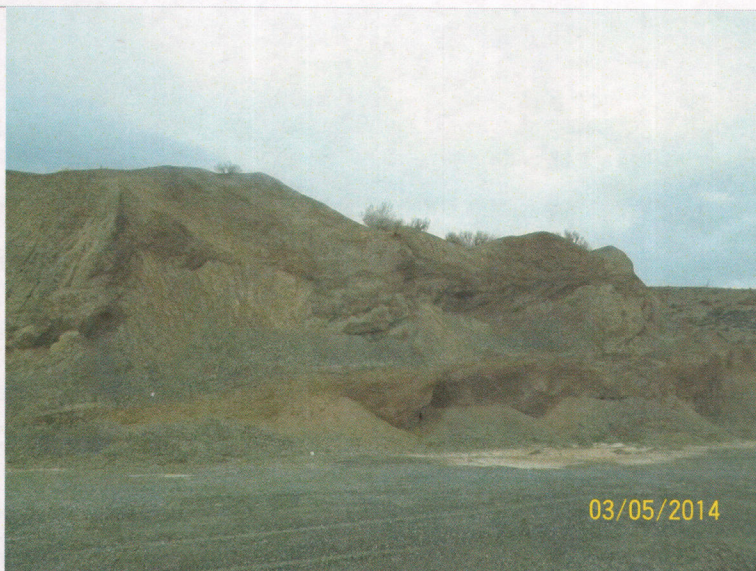
2.	<i>Public Safety (shafts, adits, trash, signs, highwalls)</i>	<input checked="" type="checkbox"/>	<input type="checkbox"/>
The stockpile to the west of has been observed to be a safety hazard in the past inspection. This material is being removed and brought to an approximate 3:1 slope as per the Division's prior recommendation.

Before photo of stockpile of road base located on the adjacent private property to the west. Material is at an unsafe slope and needs to be brought down to an approximate 3:1 slope.

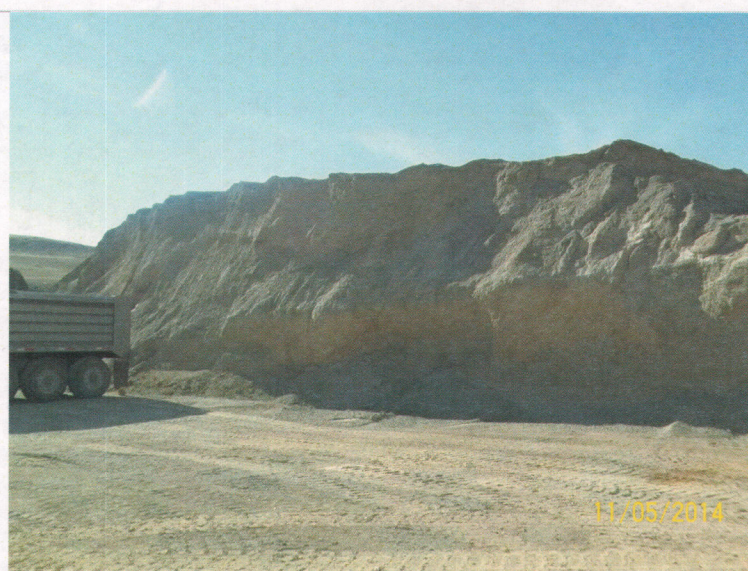
Some progress is being made on bringing this stockpile down to 3:1 but more work is needed.
